# HABITAT CONDITIONS

#### **Channel Alterations**

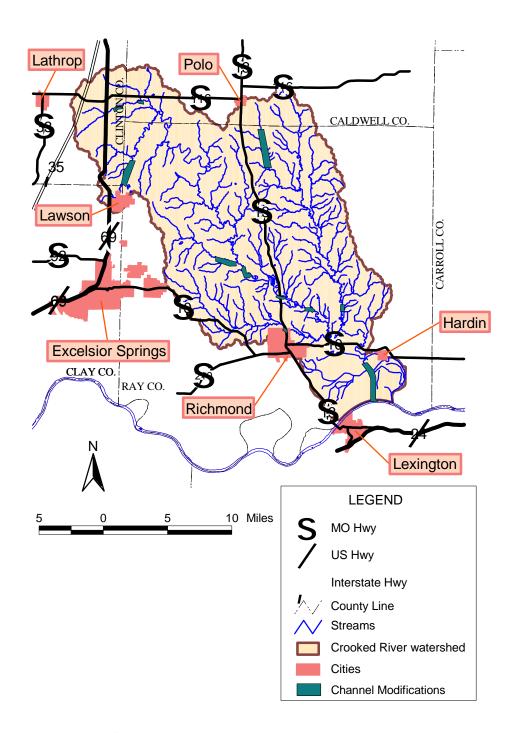
Figure 6. Areas in the Crooked River basin that are noticeably affected by channelization, located using orthophoto quadrangle and topographic maps.

Stream channels in the lower Crooked River basin are deeply incised due to downcutting caused by channelization. Channelization increases the velocity of a stream which in turn increases erosion of the streambed and stream banks. Additional effects of channelization on basin streams are increased erosion, increased sediment bedload, steepened banks, and increased instream woody debris. The upper reaches of the basin where the streambed is predominantly bedrock, show less effect from downcutting and erosion than the lower reaches in the basin. Stream bed and bank modification was apparent at several bridges in the basin. From visual observation, agricultural activities in the upper part of the basin appear to consist primarily of pasture grazing and hay operations with row crops predominant in lower areas of the basin. This may be a reason for improved water clarity as you move progressively higher in the basin.
